Site Name: Progress Energy Asheville Date: 29 MAY 2009  
 Unit Name: 1964 POND Operator's Name: PROGRESS ENERGY  
 Unit I.D.: \_\_\_\_\_ Hazard Potential Classification: High Significant Low  
 Inspector's Name: FREDERIC SHMURAK / JUSTIN STORY

Site Name: Progress Energy Asheville Date: 29 May 2009  
 Unit Name: 1982 POND Operator's Name: PROGRESS ENERGY  
 Unit I.D.: \_\_\_\_\_ Hazard Potential Classification: High Significant Low  
 Inspector's Name: Frederic Shmurak / JUSTIN STORV

PHOTOGRAPH LOCATION PLAN  
OKLAHOMA LAKE DAM - PROGRESS ENERGY  
ASHEVILLE STEAM ELECTRIC PLANT  
OKLAHOMA AND NORTH CAROLINA

**PHOTOGRAPH LOCATION PLAN  
ASH PONDS - PROGRESS ENERGY  
ASHEVILLE STEAM ELECTRIC PLANT  
SKYLAND, NORTH CAROLINA**

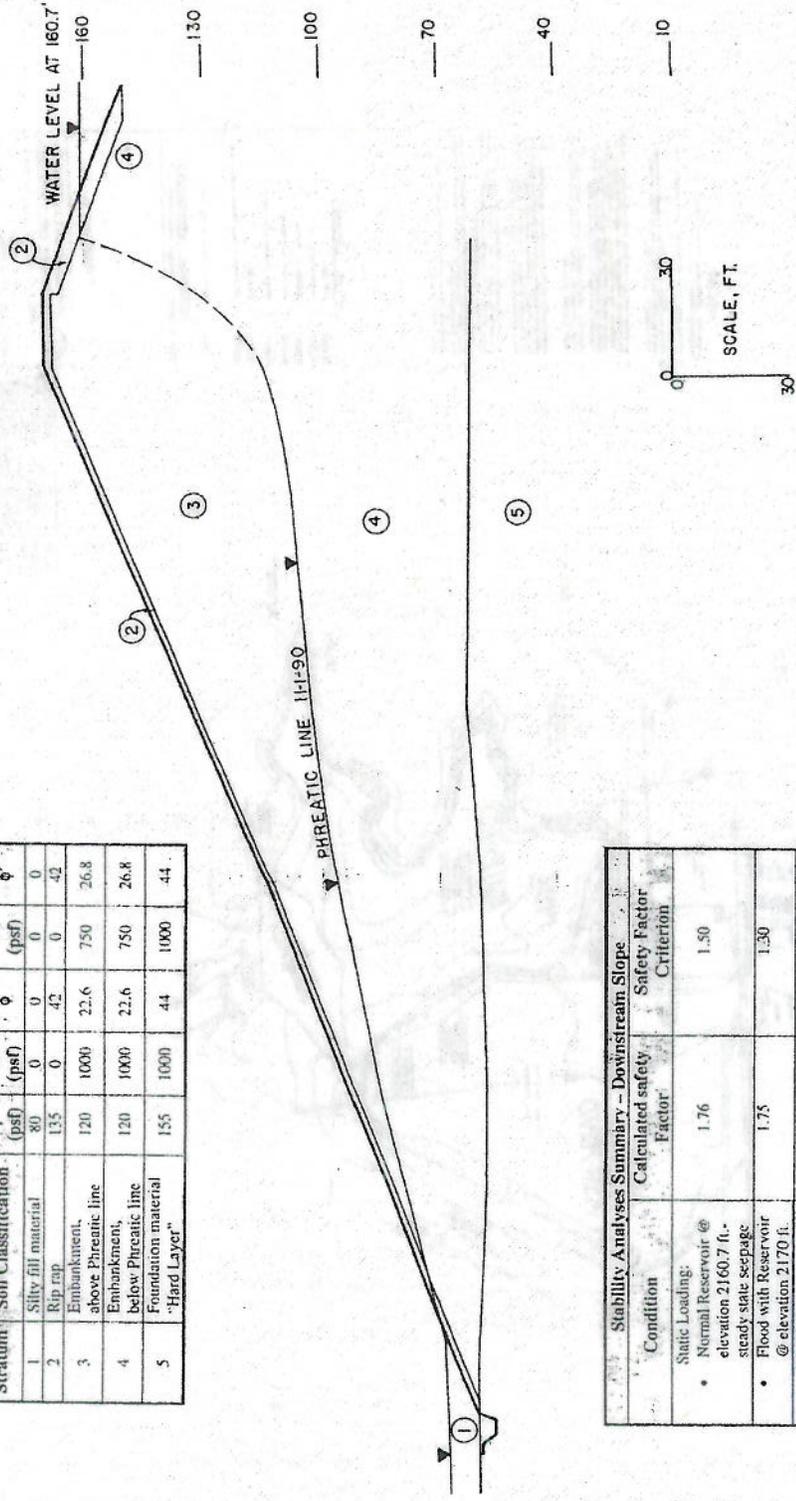
STABILITY MODEL - DOWNSTREAM SLOPE - COOLING LAKE DAM  
PROGRESS ENERGY  
ASHEVILLE STEAM ELECTRIC PLANT  
SKYLAND, NORTH CAROLINA

Stratum	Soil Classification	$\gamma$ (psf)	C (psf)	$\phi$	$C'$ (psf)	$\phi'$
1	Silty fill material	80	0	0	0	0
2	Rip rap	135	0	42	0	42
3	Embankment, above Phreatic line	120	1000	22.6	750	26.8
4	Embankment, below Phreatic line	120	1000	22.6	750	26.8
5	Foundation material - "Hard Layer"	155	1000	44	1000	44

Condition	Stability Analyses Summary - Downstream Slope	
	Calculated safety Factor	Safety Factor Criterion
Static Loading:		
• Normal Reservoir @ elevation 2160.7 ft. - steady state seepage	1.76	1.50
• Flood with Reservoir @ elevation 2170 ft.	1.75	1.30
Seismic Loading:		
• Normal Reservoir @ elevation 2160.7 ft. - steady state seepage	1.20	1.0

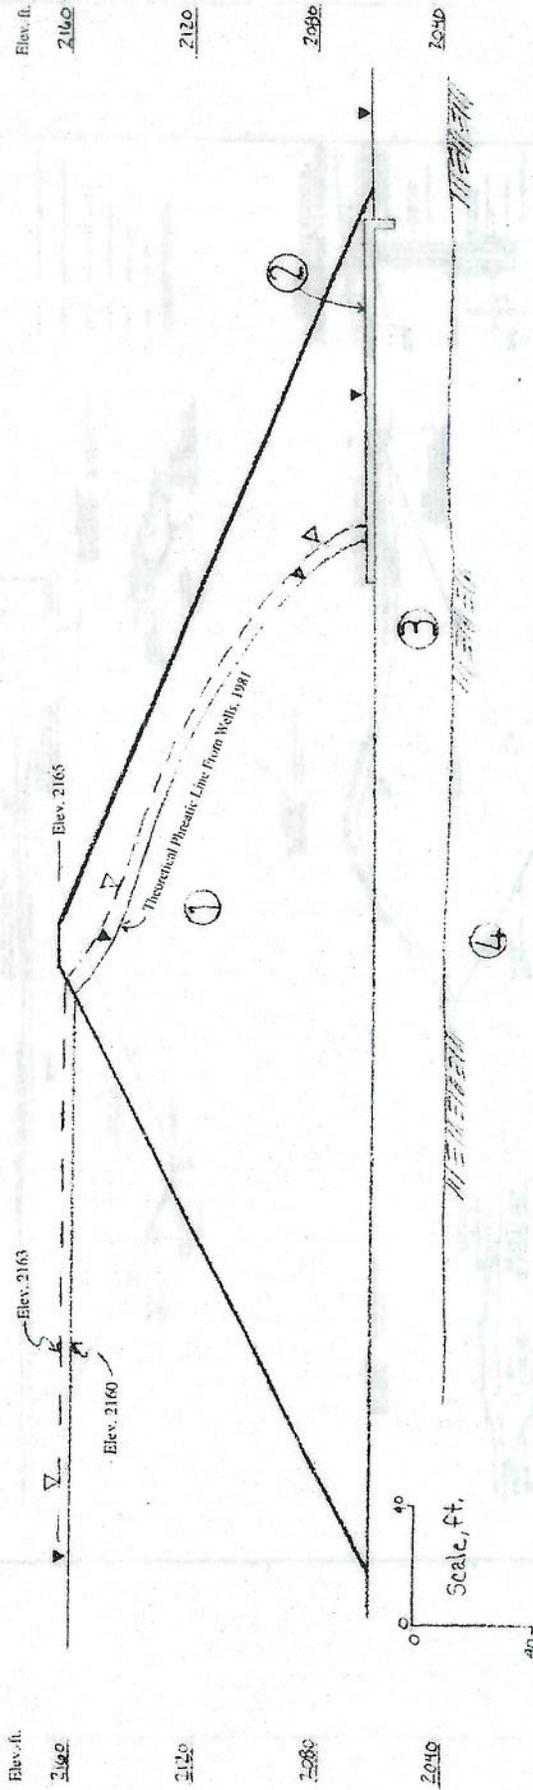
STABILITY MODEL - DOWNSTREAM SLOPE - 1982 ASH POND DAM  
PROGRESS ENERGY  
ASHEVILLE STEAM ELECTRIC PLANT  
SKYLAND, NORTH CAROLINA

Value obtained from Wells, 1981 - otherwise assumed based on experience with similar soils.

Stability Analyses Summary - Downstream Slope		
Condition	Calculated safety Factor	Safety Factor Criterion
Static Loading:		
• Reservoir @ elevation 2160 ft.-steady state seepage	1.68	1.50
• Reservoir @ elevation 2163 ft.-steady state seepage	1.63	1.50
Seismic Loading:		
• Reservoir @ elevation 2160 ft.-steady state seepage	1.07	1.0
• Reservoir @ elevation 2163 ft.-steady state seepage	1.03	1.0

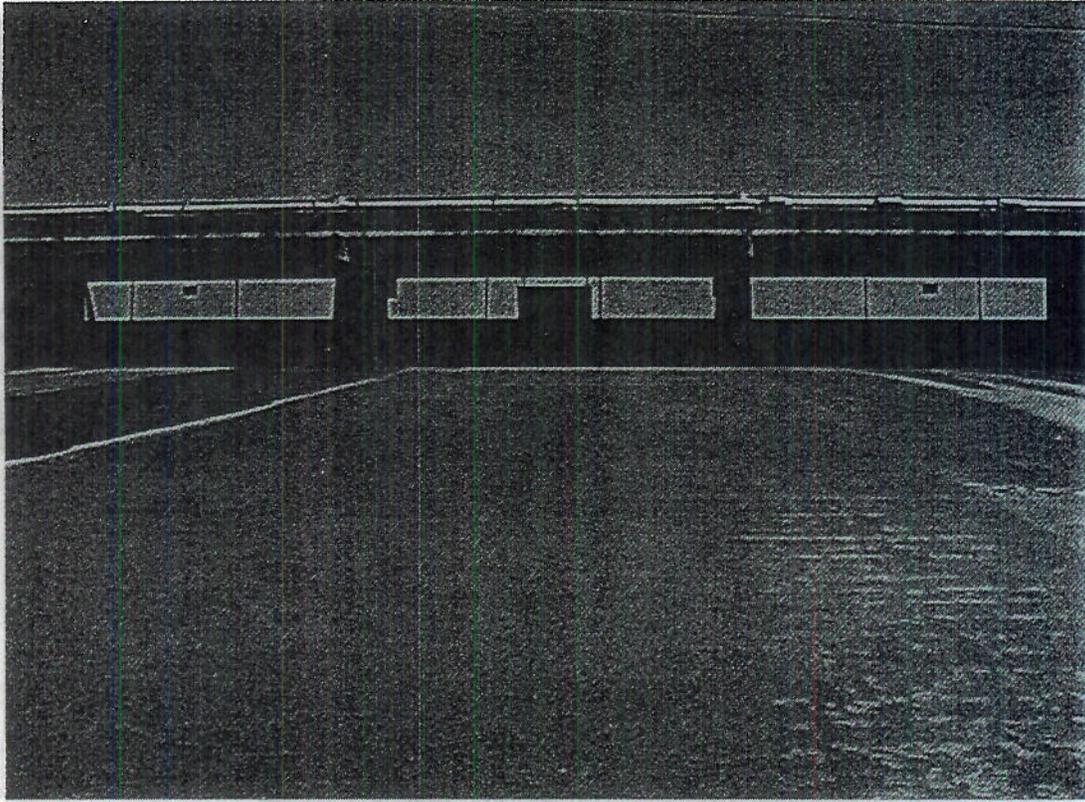
The concrete spillway (photograph 7) is in overall good condition. A minor amount of scaling was noted on the ogee section, as during the last two 5-year inspections (photograph 8). Surface cracks in ogee spillway have been caulked. The concrete wing walls are in good condition. Spalling concrete on the surface of the spillway slab was noted at the juncture of longitudinal and transverse construction joints at several locations (photographs 9 and 10). These areas (measured as 18 inch by 27 inch triangle on the left side, 3 feet by 8.5 feet triangle on the upper right side, and 12 inch by 18 inch and 6 inch by 6 inch triangles on the lower right side, looking towards the Cooling Lake) warrant repair. No flow was observed from the spillway slab underdrains.

Photograph 7: Cooling Lake Dam – ogee spillway.

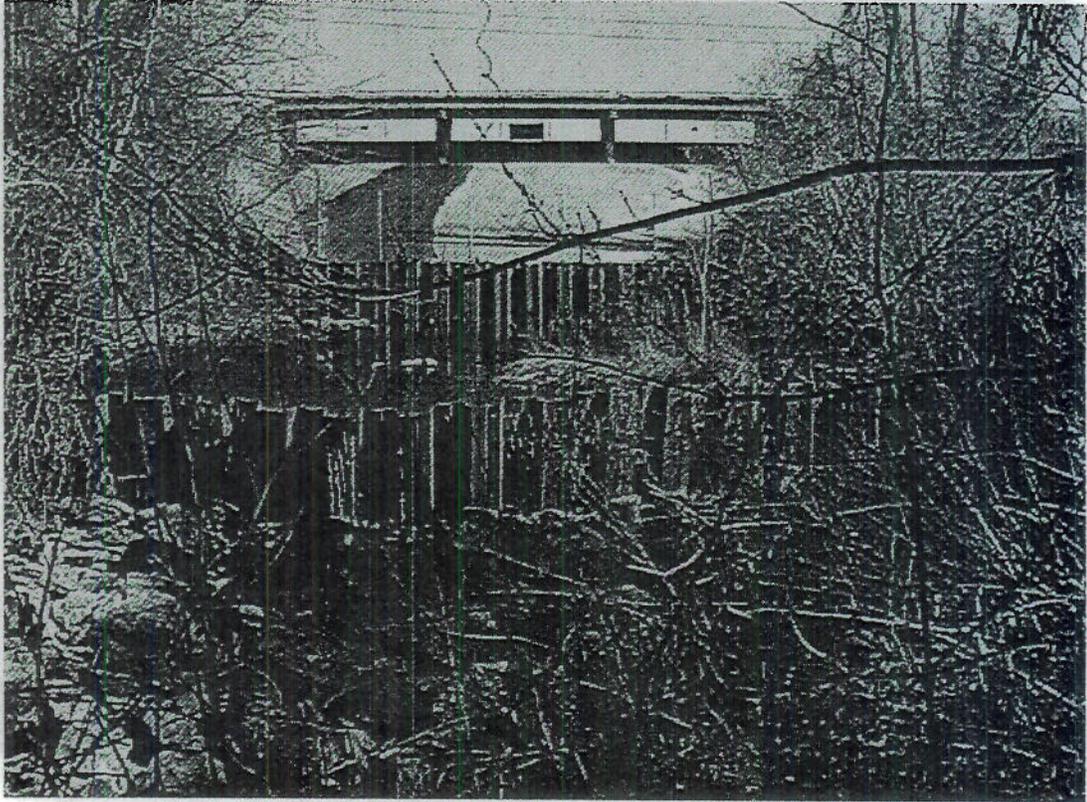
The stilling pools are also in good condition. The first stilling pool has scattered rip-rap along the bottom and is in about the same condition as reported in the 2002 inspection report. The displaced sheet piles creating this pool appear not to have changed, judging from previous reports (photographs 11 and 12). The second pool located downstream from the first also appears to be in generally good condition.

Photograph 11: Cooling Lake Dam – spillway drop walls and energy dissipation pool.

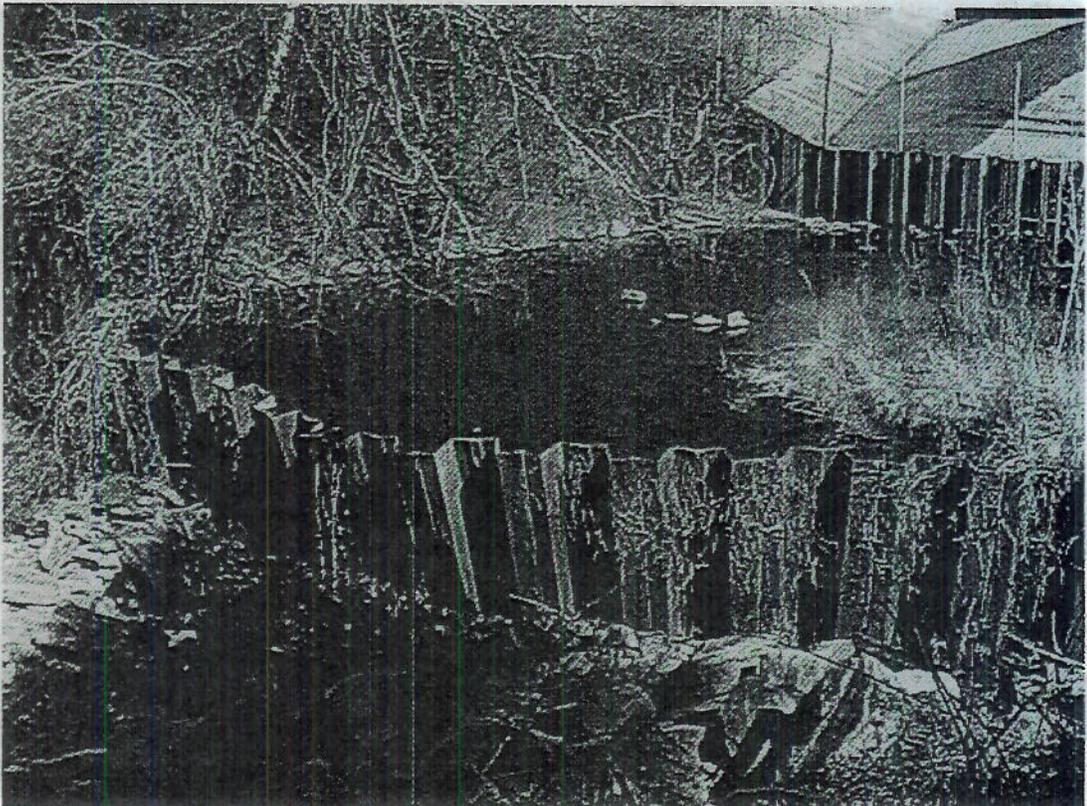
Photograph 12: Cooling Lake Dam – spillway drop walls and energy dissipation pool.

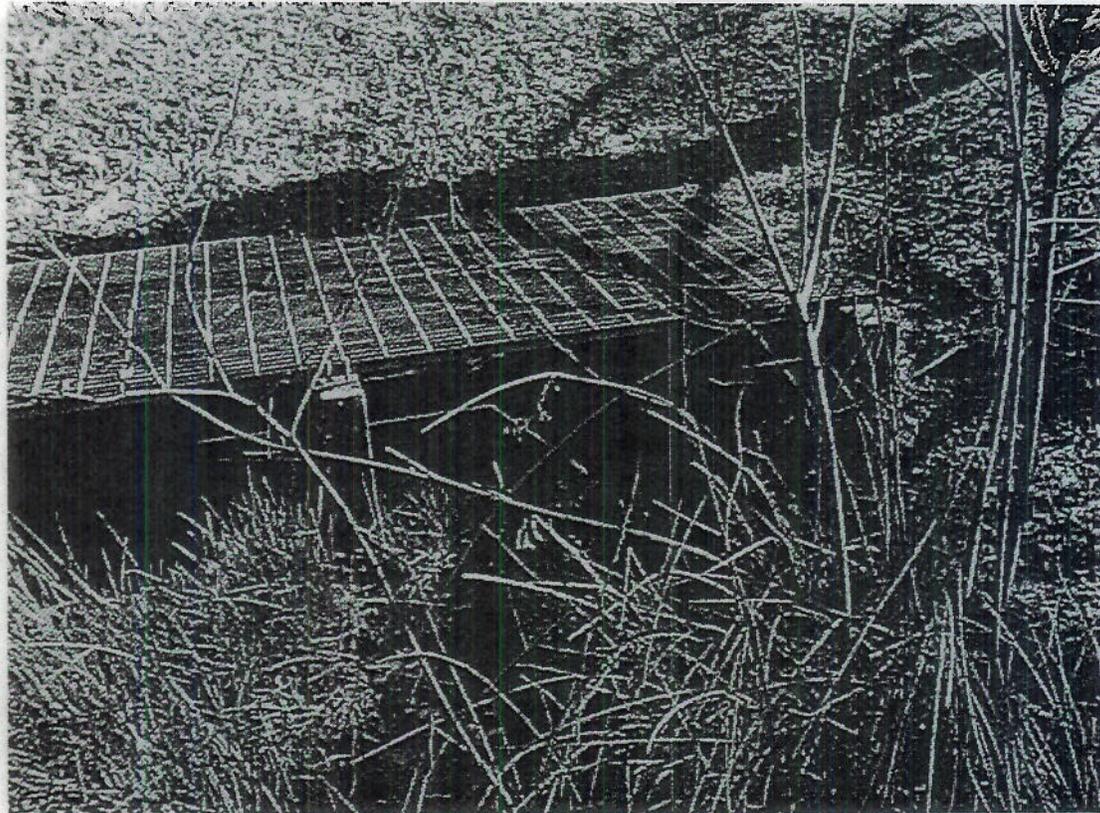
Photograph 21: 1982 Ash Pond – Seepage Monitoring Weir

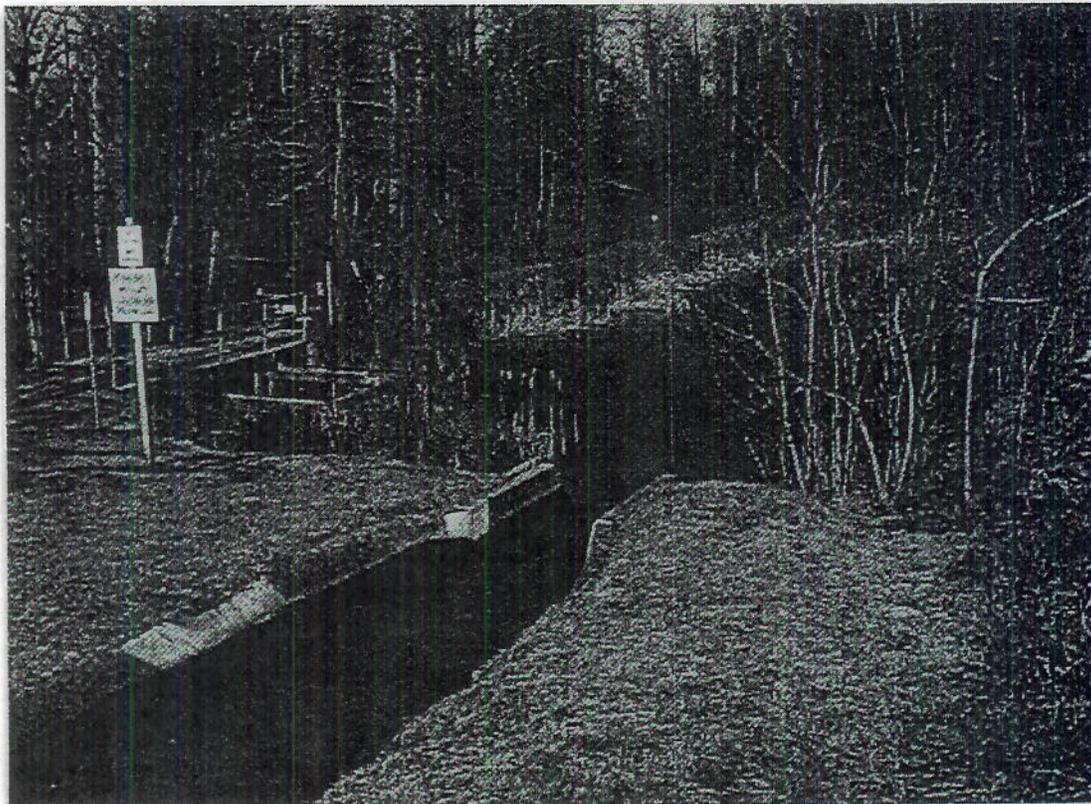
The skimmer, stilling basin and outlet structure are in good condition (photographs 25 and 26). No evidence of deteriorating concrete was observed at the outlet structure.

Photograph 26: 1964 Ash Pond - concrete flume discharge into stilling pond.

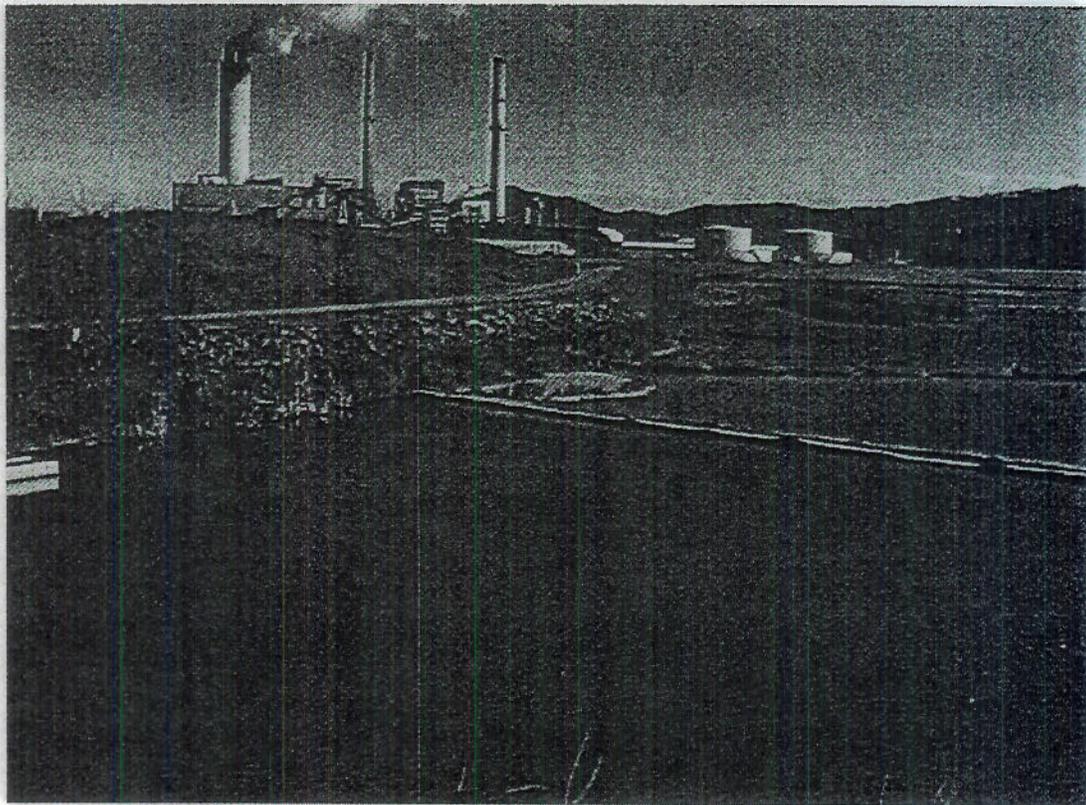
With construction of the 1982 Ash Pond, the southeast portion of the 1964 Ash Pond dam became a separator dike (photograph 27). At the time of the 1987 inspection, the southernmost portion of this dike had experienced a minor slide of the rip-rap into the new ash pond. The linear extent of the slide was about 225 feet and the slide depth appeared to be shallow, not extending into the soil portion of the dike. No significant movements appear to have taken place in this area subsequent to the 1987 inspection. The slope appears to remain in relatively good condition 20 years after the slide. Ash reclaimed from the 1982 pond has been dry stacked within the former 1964 Ash Pond near the separator dike, effectively reducing the height of the separator dike along approximately  $\frac{3}{4}$  of the length of the separator dike.

Photograph 27: Dike between 1982 Ash Pond and 1964 Ash Pond, interior slope, looking west.

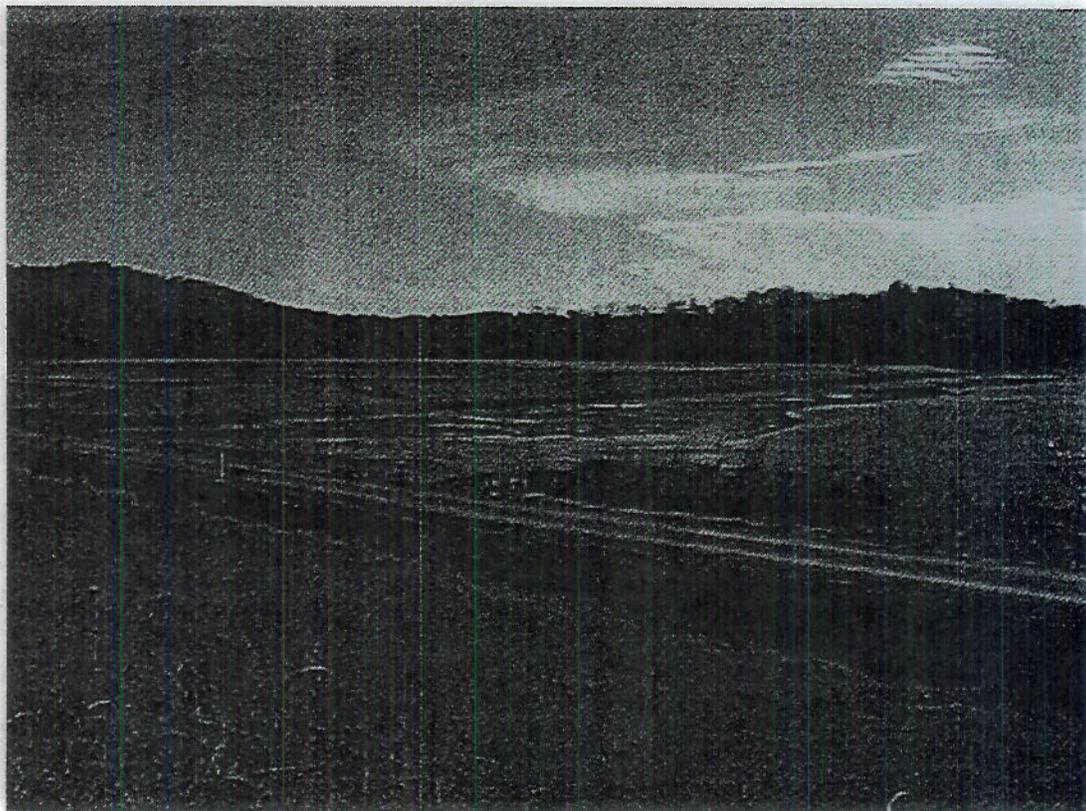
The internal ash dike, located within the northern half of the 1982 Ash Pond (photograph 28), was constructed in 2006 with ash excavated from the 1982 Ash Pond. The internal ash dike was observed to be in overall good condition. Grass cover was observed on the upstream and downstream slopes of the internal ash dike (photograph 29). The outlet pipe located at the southeast corner of the internal dike appears to be in good condition (photograph 30).

Photograph 28: 1982 Ash Pond and internal ash dike within 1982 Ash Pond, looking northeast.

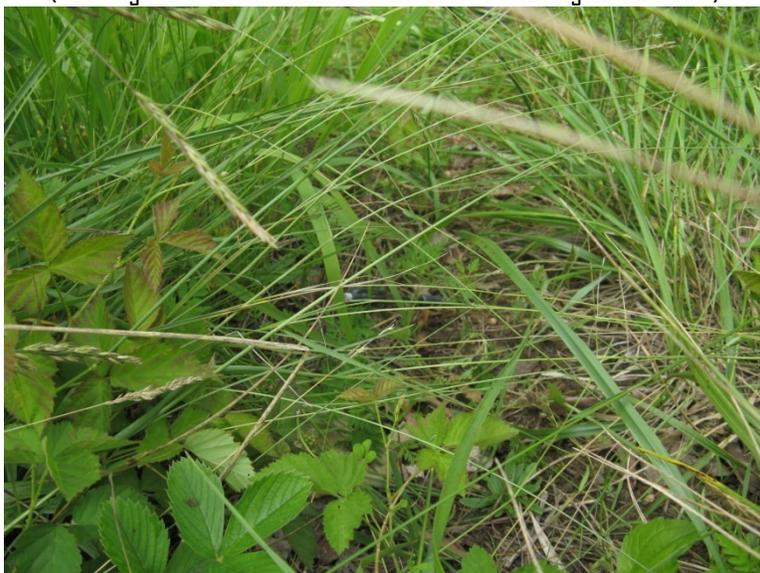
Photo 14: 1982 Dam - Animal Burrow, Downstream Embankment 50' Right of Piezometer, Photo: 028, 5/29/09  
 (note: right and left are based on the observer facing downstream)

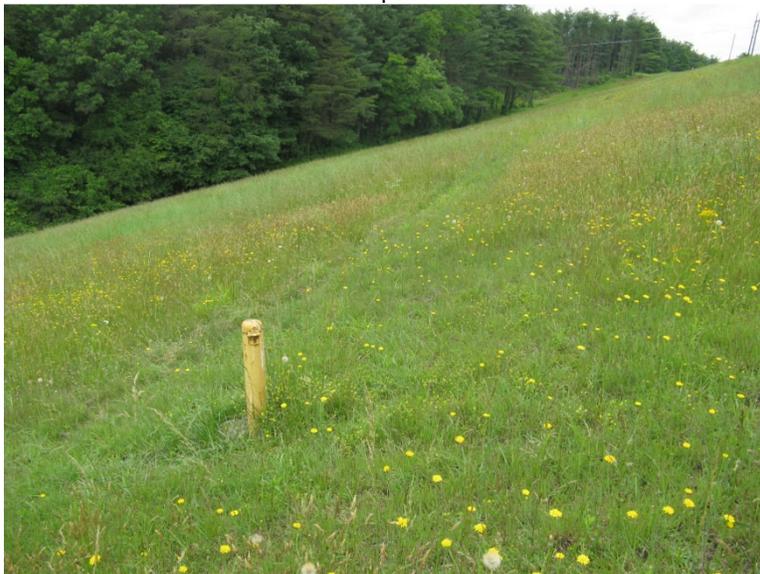
Photo 15: 1982 Dam - Midsection of Downstream Slope, Downstream Embankment, Photo: 030, 5/29/09

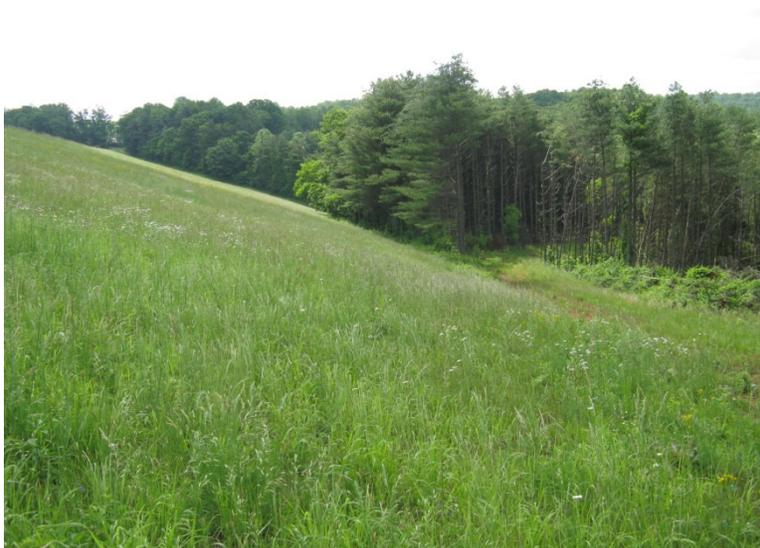
Photo 16: 1982 Dam - View of Right Grain, Right Abutment, Photo: 016, 5/29/09  
(note: right and left are based on the observer facing downstream)

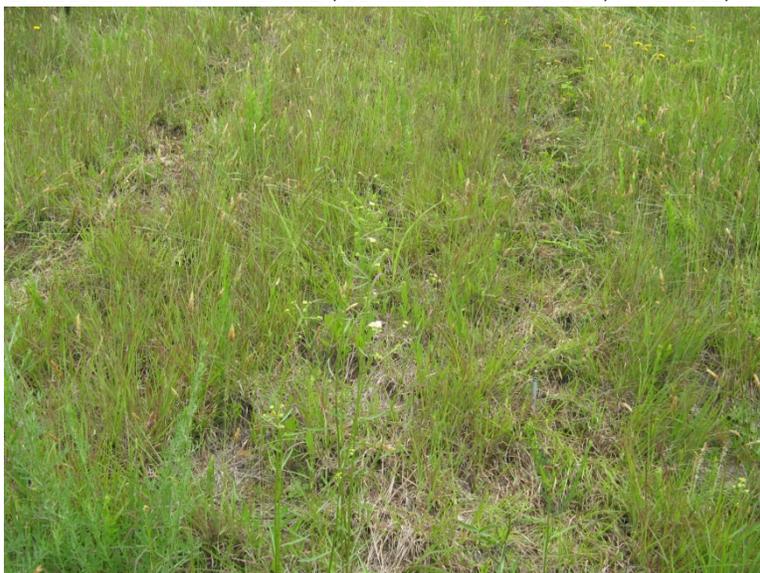
Photo 18: 1982 Dam – Minor Rill Erosion, Downstream Embankment, Photo: 033, 5/29/09
